Results and Recommendations of Forensic Investigation of Three Full-Scale GRS Abutment and Piers in Denver, Colorado

June 2001

**COLORADO DEPARTMENT OF TRANSPORTATION
RESEARCH BRANCH**

1. Report No. CDOT-DTD-R-2001-6	2. Government Accession No.	3. Recipient's Catalog No.	
4. Title and Subtitle Results and Recommendations of Forensic Investigation of Three Full-Scale GRS Abutment and Piers in Denver, Colorado		5. Report Date June, 2001

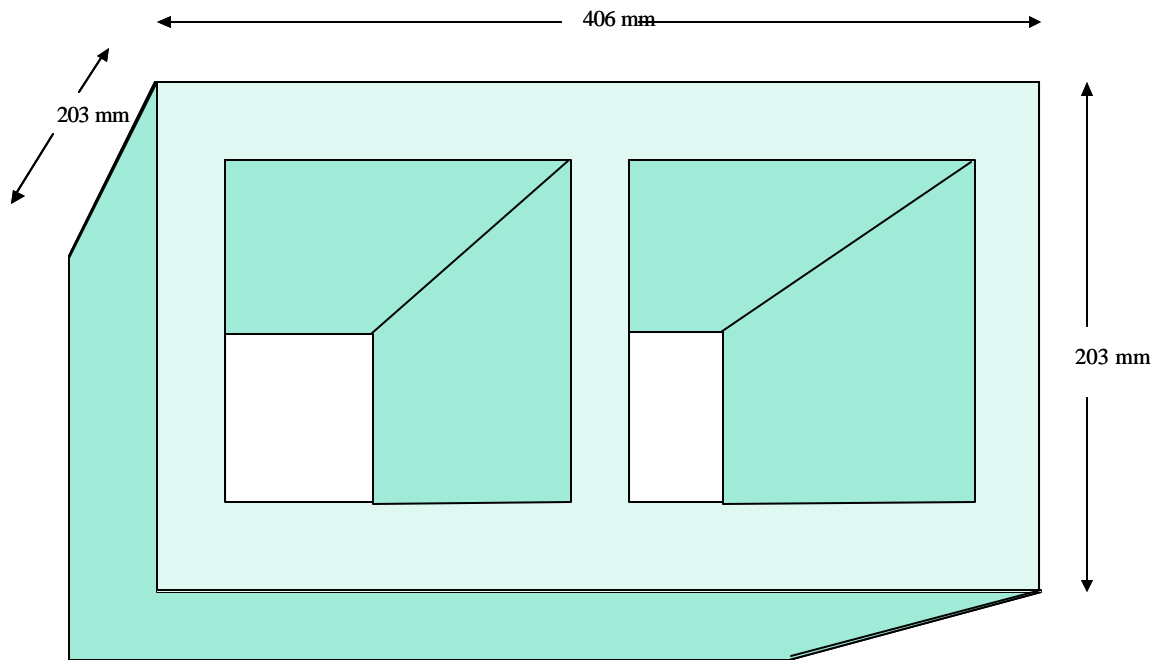
Figure 3 Typical Block from East Abutment Structure (133 to 182 N or 30 to 41 lb. in weight)

The blocks for the abutment structure (Figure 3, Photo 2 Appendix A) were supplied by several manufacturers (Amoco Fabrics & Fibers, Best Block, Clalite, Retaining Wall Systems, and Valley Block). The blocks were standard blocks (0.2m x 0.2m x 0.4m), made of lightweight concrete in the basic two-cell shape (Figure 3). Their weights varied from 133 to 182 newtons (30 to 41 pounds). There were few cracks visible in the external face before the dismantling began (Photo 8). During dismantling, a fairly large percentage – as high as 50% – of the blocks in some layers was internally broken. Most of the blocks on west face of the abutment (the side where surcharge load on the abutment was applied, see Figure 1) were broken. Most of the blocks on the north, east, and south faces of the abutment were unbroken. Many of the blocks that were broken did not have visible cracks before dismantling of the structure. A block that had a crack that ran completely from the top to the bottom and half way through the center web is shown in Photo 12 (Appendix A). There did not seem to be any correlation between the layer location (depth) and the percentage of broken blocks.

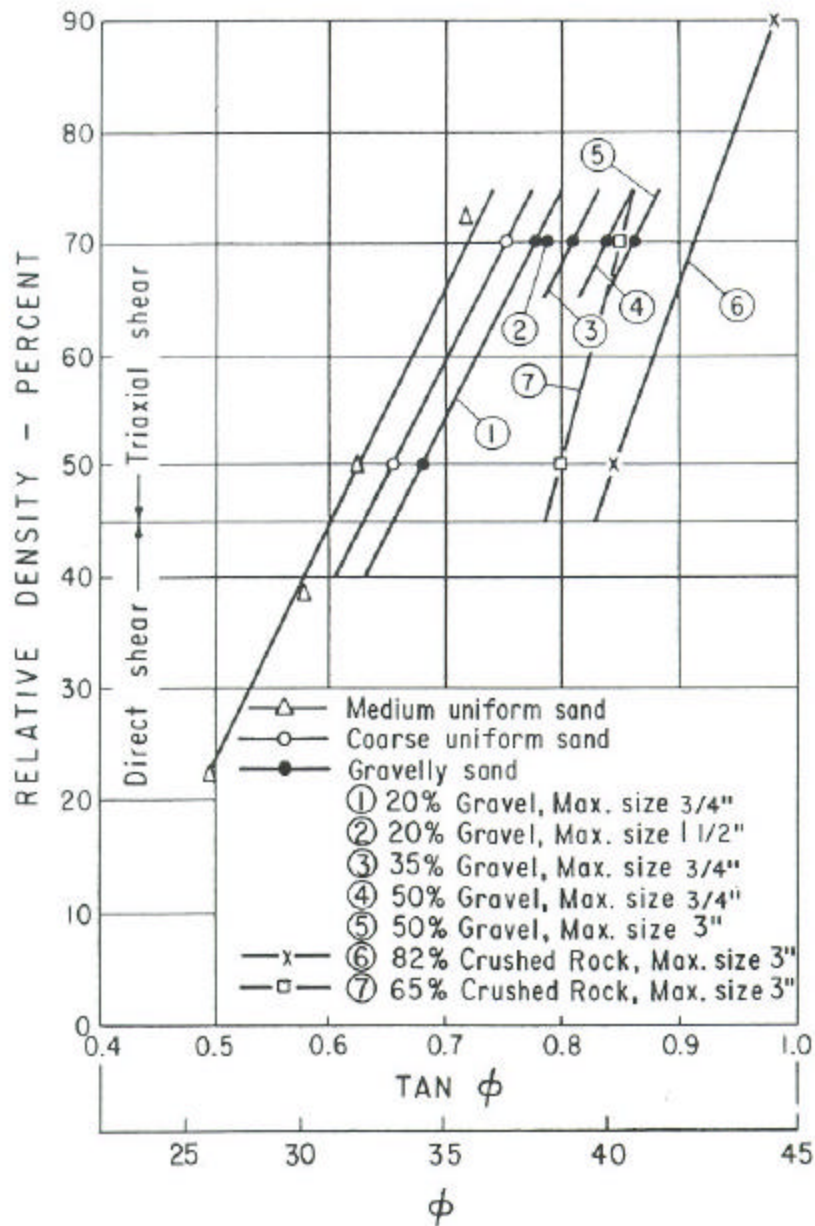
Figure 14 Effect of Relative Soil Density on the Soil Friction Angle, tan ϕ , for Coarse-Grained Soils (USBR, 1998)

It was concluded in the FHWA study (FHWA 2000) that good backfill compaction is essential to satisfactory performance of GRS structures. Figure 14 shows the relation between relative density and the angle of internal friction (also expressed as $\tan \phi$) for compacted coarse-grained soils (USBR, 1998). A soil with a friction angle of 40 degrees has almost four times the bearing capacity of a soil with a friction angle of 32 degrees.

Chapter 2 concluded that the backfill compaction level for the Havana Yard GRS structures was variable and low, especially close to the facing, not meeting CDOT requirements of 95% of AASHTO T-180 method (see Table 2). The non-smooth pier deformation response from row 11 to row 14 (Figures 8 and 9) could be attributed to the variable and low applied backfill compaction level. According to CDOT design specifications, a compaction level of 95% is required to achieve a minimum backfill friction angle of 34 degrees. Hence, the friction angle for the outer pier backfill is expected to be lower than 34 degrees, especially close to the facing. The comparatively low backfill compaction level led to a low strength (i.e., bearing capacity) and stiffness of the reinforced soil mass (Figure 14), lower reinforcement pull-out resistance, higher lateral earth pressures and facing connection loads, and non-uniform distribution of surcharge loads over the pier area, especially in the top zone. Therefore, the lower backfill compaction level resulted in relatively more deformation to the pier.

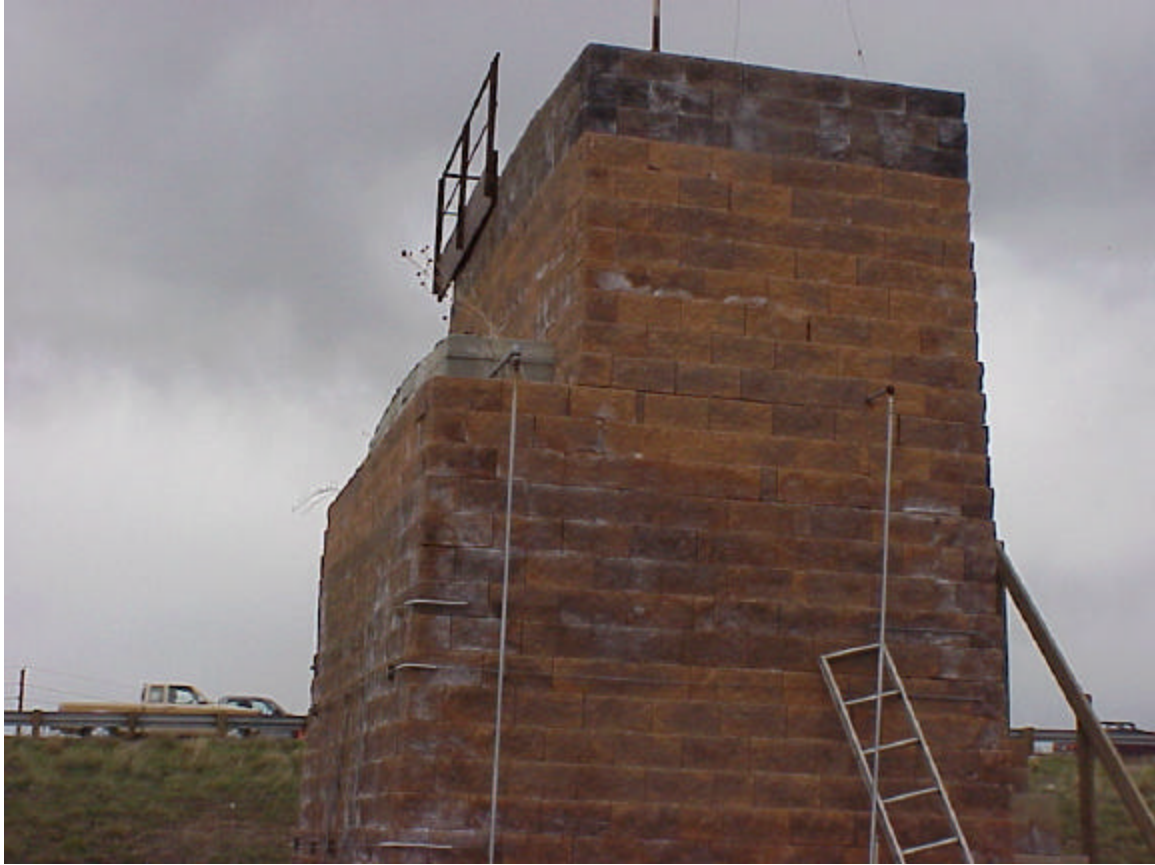
Photo 2. Upper Portion of the Abutment Structure.

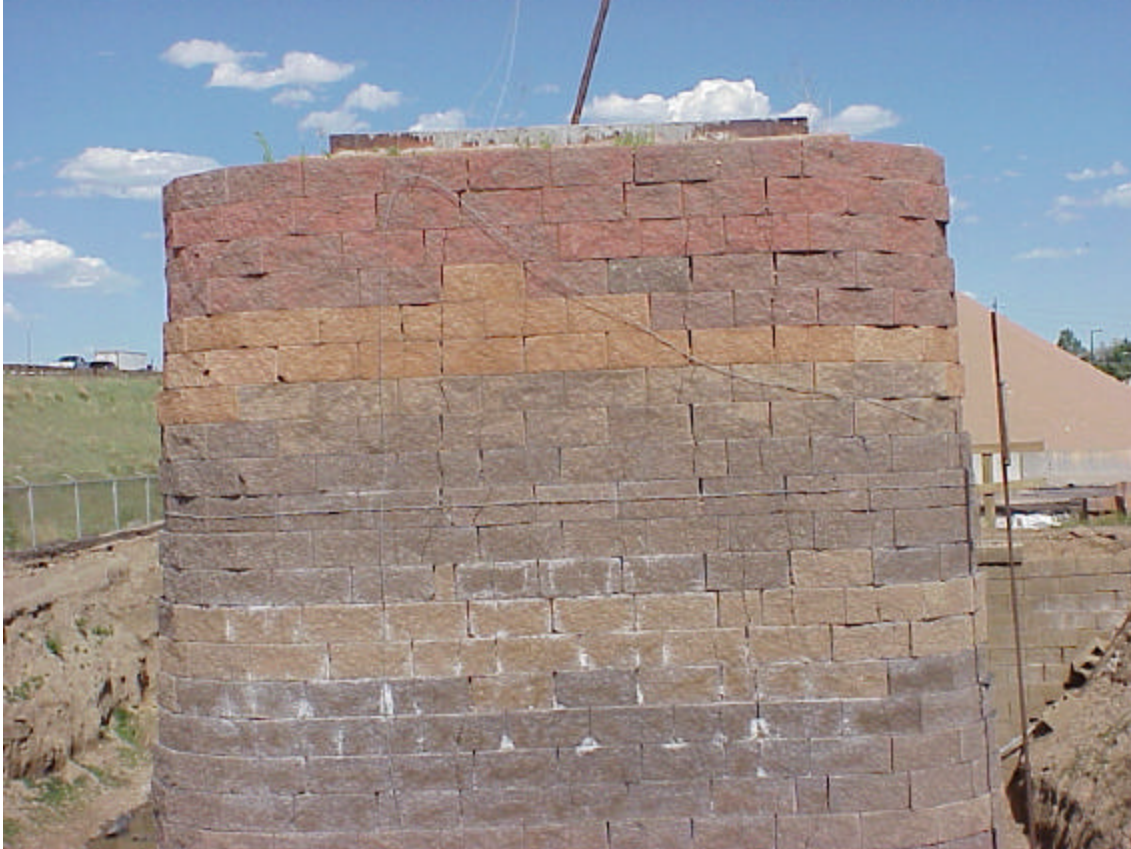
Photo 5. The Outer Pier Structure.

The excessive deformations in the upper zone of the pier were evidence of a bearing capacity problem. Both the results of forensic investigation and facing connection stability analysis indicate that layers 25 to 38 of the outer pier failed in meeting the serviceability block-to-block connection requirements (i.e., relative displacement between block layers was larger than 4 mm). Potential reasons for the excessive deformation and cracking of the Havana outer pier are: high surcharge load applied to a limited surface area of a slender pier, low and variable backfill compaction level, low facing connection strength and reinforcement pullout resistance in the upper zone of the pier, weak blocks, and seasonal changes of temperature and moisture. The comparatively low backfill compaction level led to increased lateral earth pressure loads and to decreased strength and stiffness of the reinforced soil mass. The construction of the pier during the cold season may have delayed the excessive movement and cracking of the pier facing. The delay in the development of structure movements, which appeared several months after loading during the 1997 spring season, was attributed to softening of the backfill that may have resulted from low backfill compaction and soil wetting due to rain and ice melting.

Since the blocks of the outer pier structure were severely cracked and the upper four rows showed significant movements (see Photos 5, 6 and 7), the external and internal conditions of blocks were thoroughly examined. The results of this examination are presented in the following subsections.

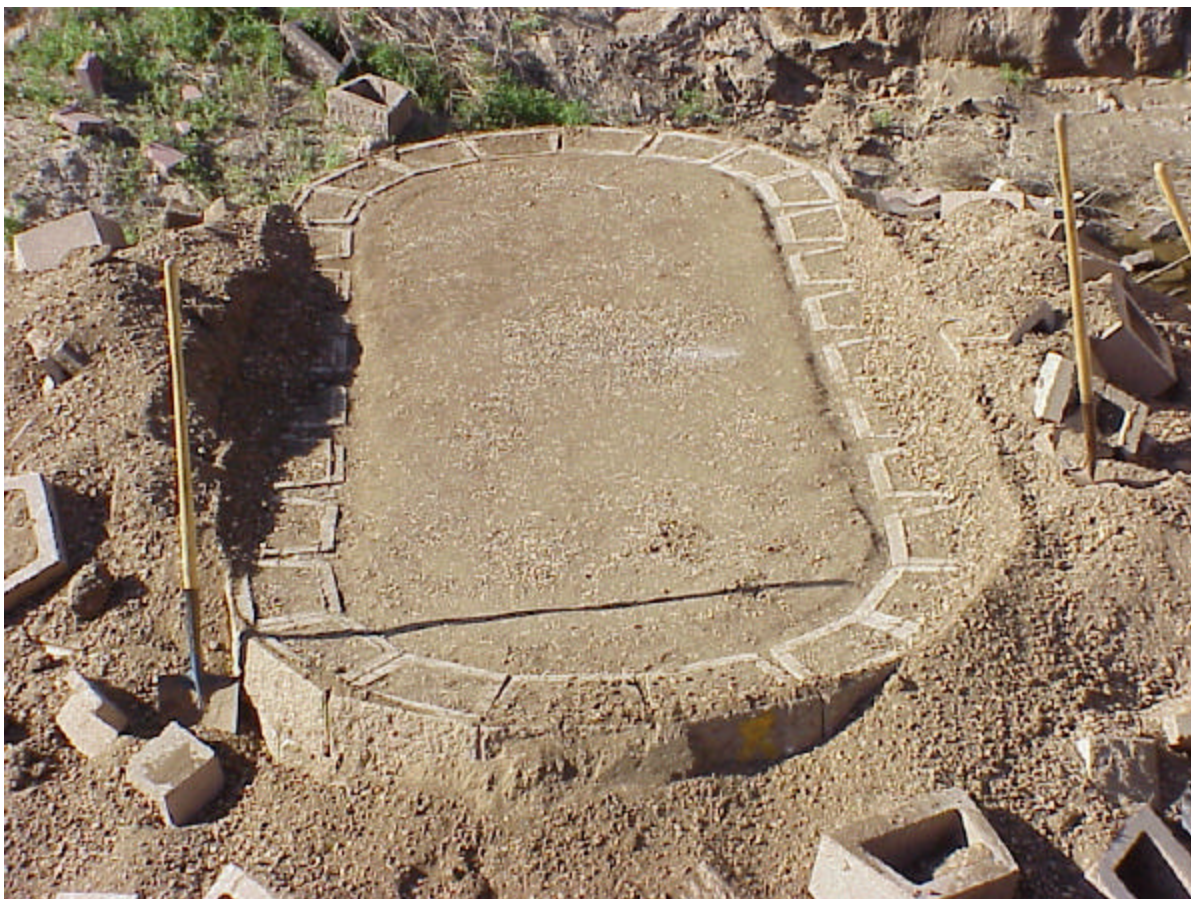
Photo 10. Dismantling in Progress: The Outer Pier at Row 10 from bottom.
